T.H.E. Home Inspection Company

For: John Smith

Address: Vancouver

Date: 2002

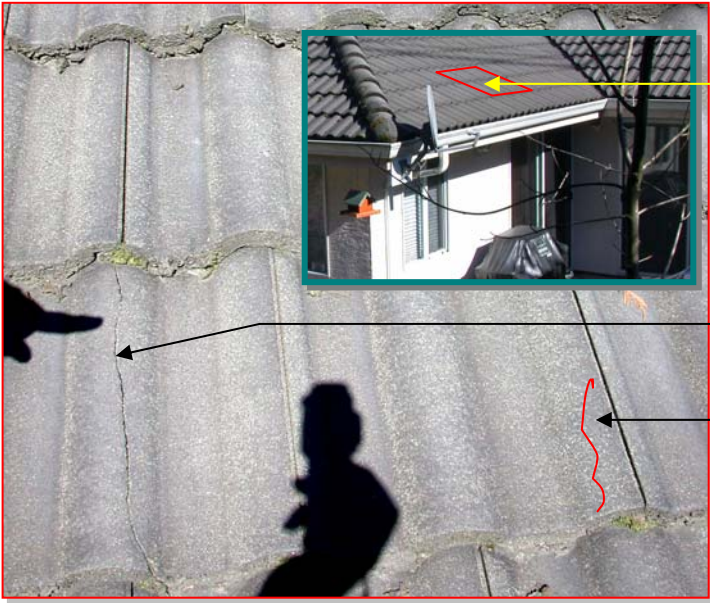
*** - approx. 8 cracked tiles p3 (cleaned and repair) **\$300**
 - approx. overall age expectancy 40 to 50 yr.

Cracked tile in photo as in this location

Approx. 8 cracked tiles possibly more
 - most of the cracked tiles are broken at tile connections as in this illustration

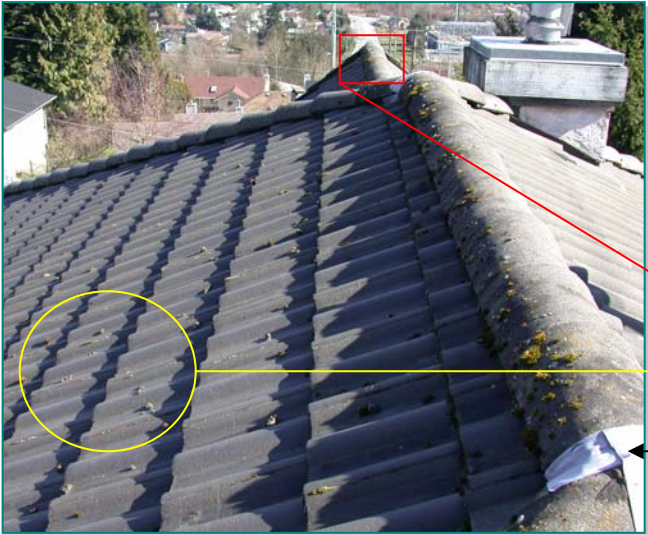
- roof flashings- no problems observed
 - *** - ridge caps- moss growth p3- recommend cleaning (do not pressure wash roof)
- Note: concrete tiles are painted with an acrylic paint- pressure washing will damage it

- Moss growth along ridges will damage acrylic finish

Southeast ridges have the most moss growth

- loose moss should be washed off the roof to prevent it from taking up residence

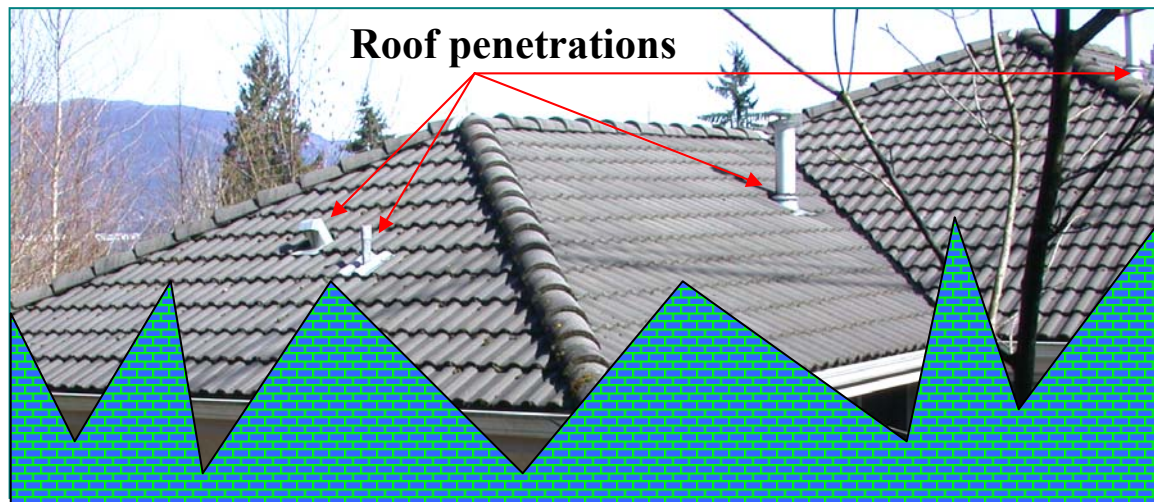
- roof penetrations- underlayment is not sealed around penetrations p4

Comment: anticipated leakage at these penetrations is minimal and would likely only occur during heavy winds

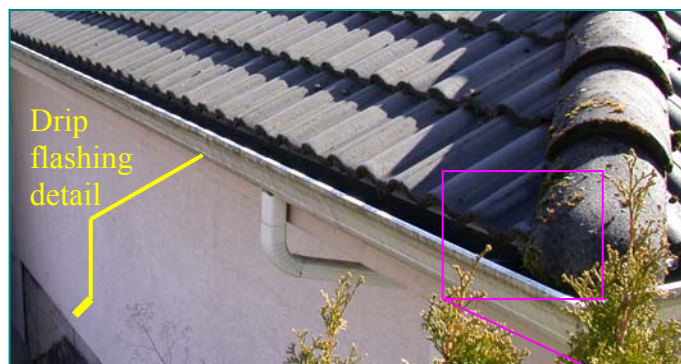
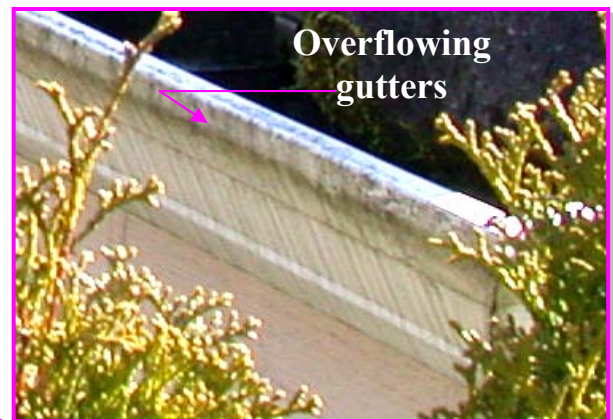
- **** - deep profile aluminum gutters- evidence of water overflowing gutters p4

Comment: overflowing gutters can cause damage to fascia (clean gutters on regular basis)

- **** Recommendation: install drip lip under underlayment to extend into gutter p4

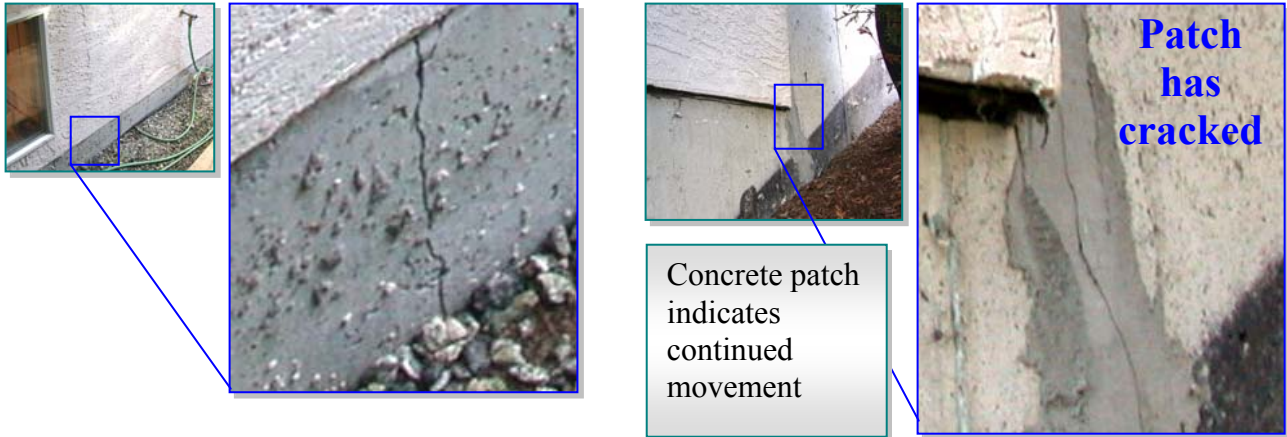
***** - 2 foundation cracks approx. 1/8" observed (east and west side p5 **\$400** of building)

Comment: these cracks are significant- indication of continued differential movement. Recommend: dig out to the foundation footing- using fiberglass mesh tape apply tar patch to prevent water ingress to interior

***** **Recommendation:** consult structural engineer- foundation may require monitoring hardware p5 installed and possibly underpinning and or anchorage (an inexpensive gauge is epoxied to the crack to measure any movement over time)

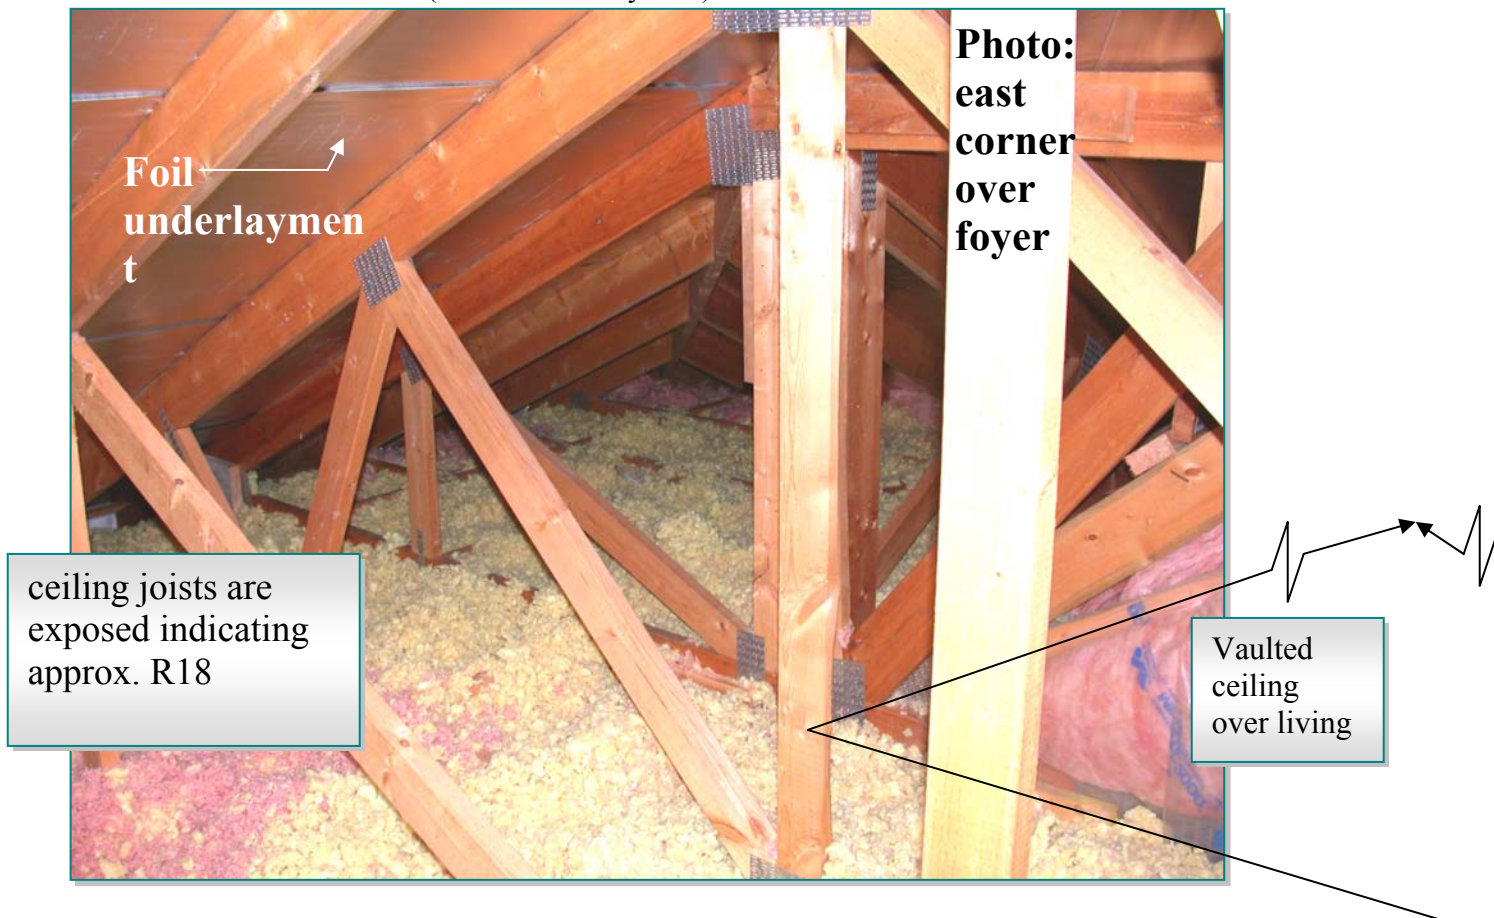
- ceiling joists/truss 2' on centers- no problems observed
- 2x6" rafters (trusses)
- foil coated polyolefin underlayment- did not observe any tears, voids, or overlapping deficiencies (that is relatively rare)

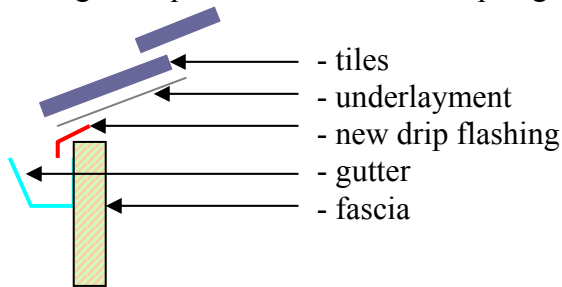
- fascia- vulnerable to gutter splash back- installed drip edge

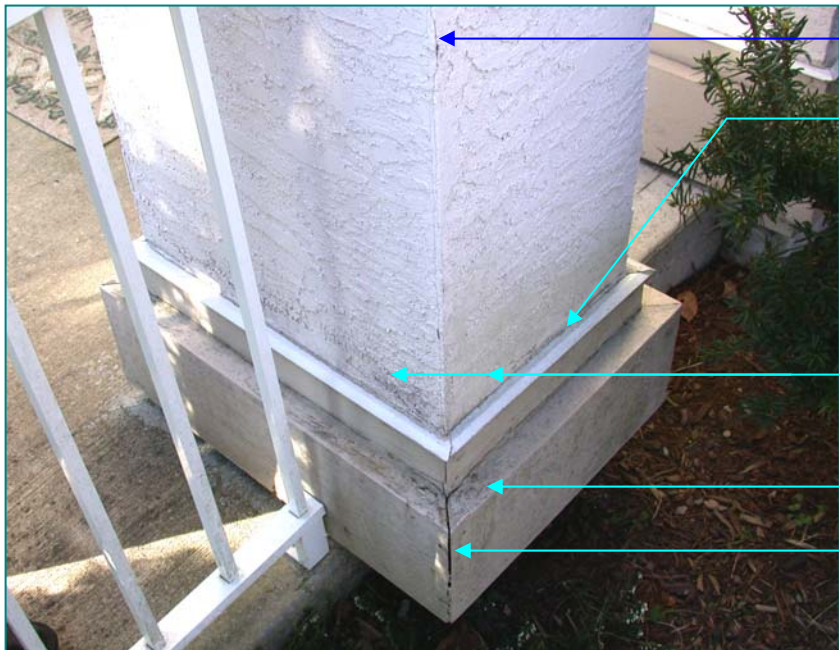
- all horizontal drip flashings e.g. wood trim are either flat or canted p7 \$1-\$1800 back to wall surface providing drainage 2 behind stucco cladding

- repair cracks in stucco
- remove all horizontal trim
- there's no capillary break between stucco and drip flashing
- drip flashings provide capillary transition for water ingress to vulnerable framing components
- staining may be indication of interior moisture related damage
- square profile of wood trim does not allow water drainage
- skirting- trim is deteriorating

Recommendation: remove all horizontal trim, cut or remove drip flashings, install new drip flashings

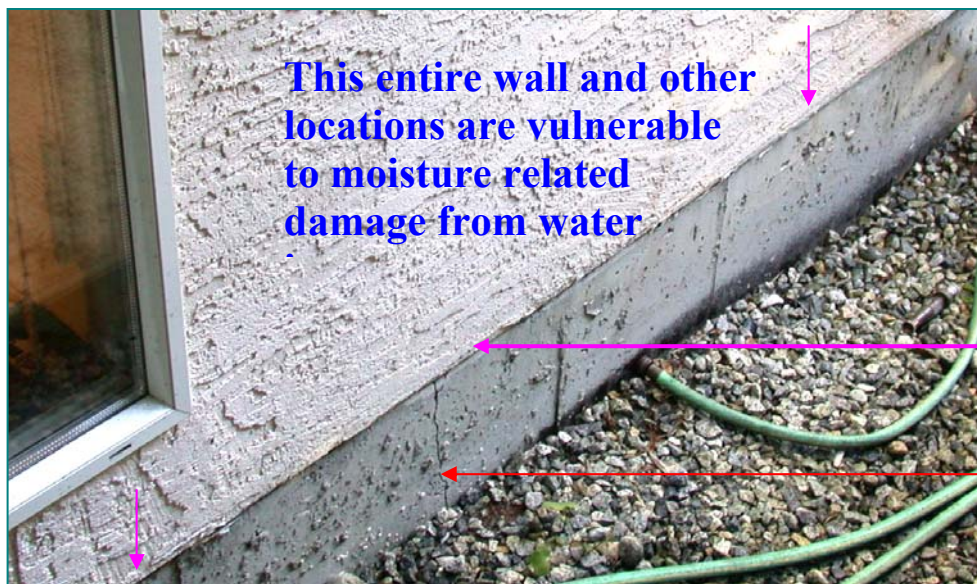
**** - stucco terminates at/in foundation "capillary break"- possible capillary water ingress p8

- stucco does not provide a drip edge preventing capillary water ingress to wall sheathing and sill plate
 - crack at west elevation

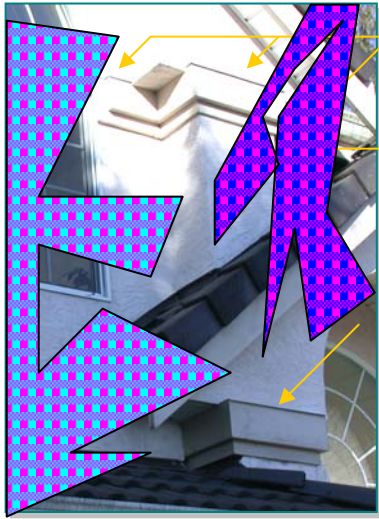
- all horizontal wood trim and drip flashings require new flashing and watershed detailing with appropriate caulking
- this roof detail should have had a cricket installed to diverge water and debris from backing up (this area should be checked every fall)

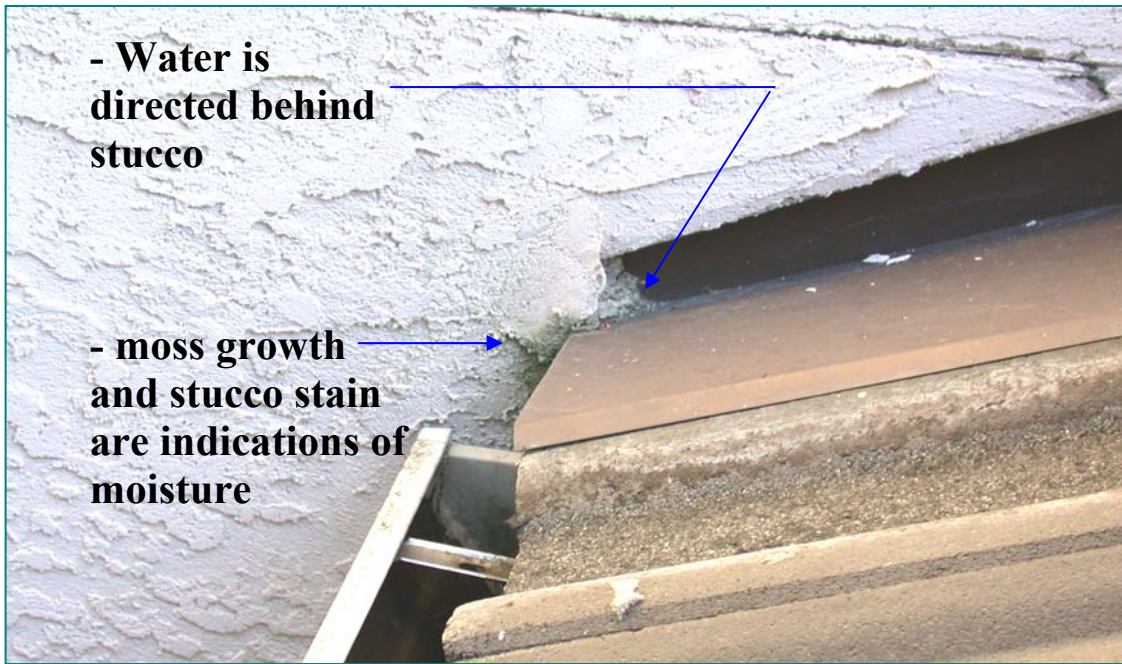
***** - roof side wall step flashings terminate behind stucco- water is directed behind stucco p9

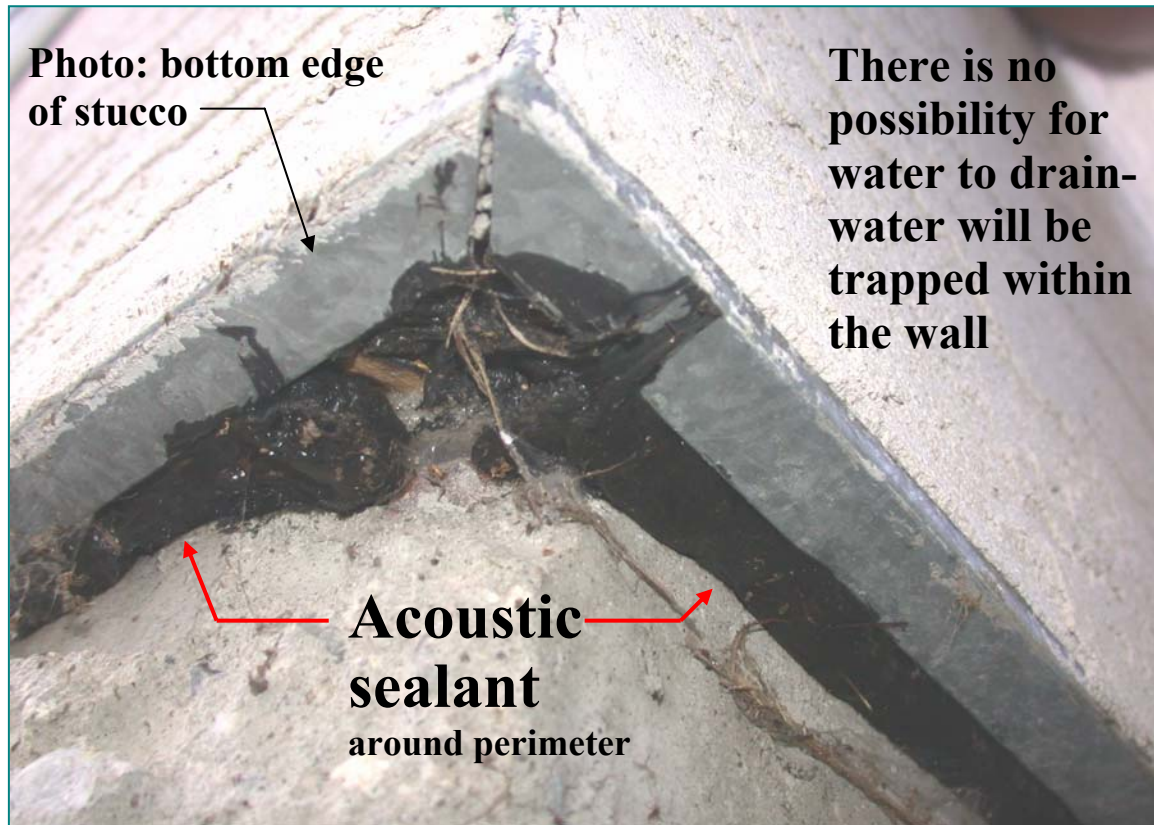
***** - the bottom edge of the stucco has been sealed preventing any drainage- it's absolutely p9 essential no water enters these walls e.g. stucco cracks, around window perimeters, and horizontal trim

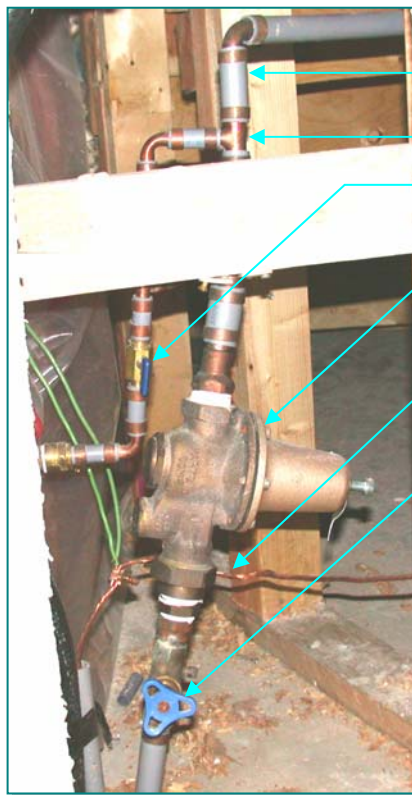
Photo: laundry room

- **** - $\frac{3}{4}$ " polybutylene service pipe has undetermined life expectancy p10

Comment: lookup polybutylene on the Internet- class-action suit (chlorine breaks this material down)

- polybutylene piping
- copper fittings
- shut off valve for frost free hose bib
- PRV (pressure reduction valve is set at 50 PSI)
- electric panel ground wire is believed to be buried in the slab
- house main shutoff

- **** - polybutylene house piping- also vulnerable to chlorine p10 (retrofit plumbing- \$35 to \$4500 (eventual catastrophic failure)
- pressure regulating valve is set at approx. 50 PSI- good
- hose bib interior shut offs- under en suite vanity, at service entrance, and kitchen sink
- back flow preventers installed on hose bibs

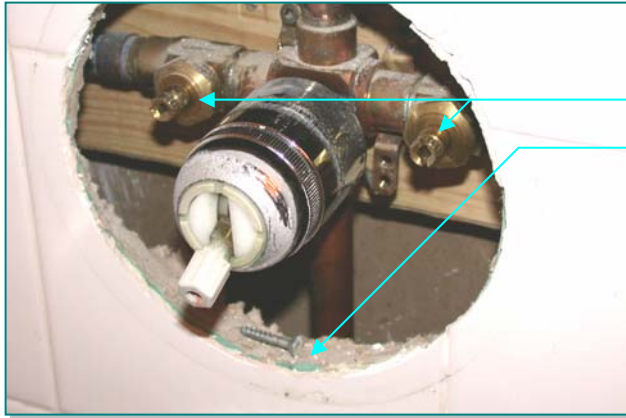
***** - basement shower escutcheon plate requires a drain hole p12

Photo: bathtub water control valve escutcheon plate removed

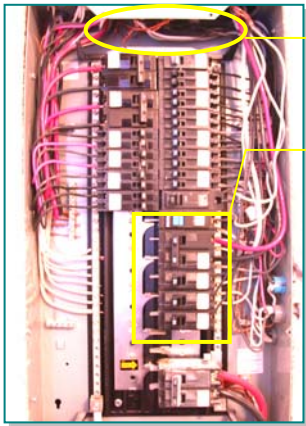
***** - no GFI. breaker for Jacuzzi - replace existing breaker with GFI p13 (actual breaker \$60-\$80)

- new circuits are not properly grounded
- these breakers/circuits were not installed with a permit

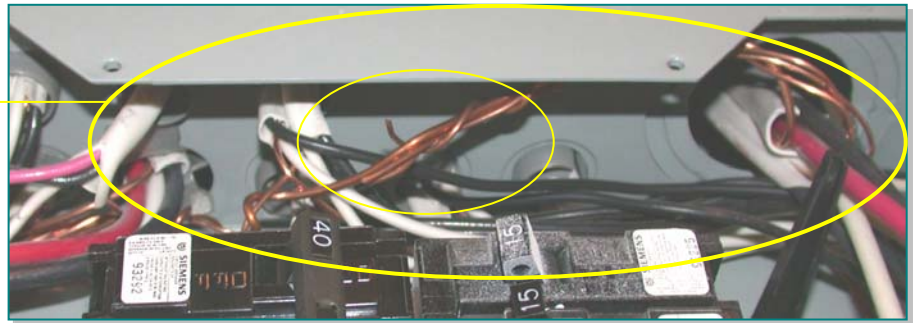
sample outlets/switches (grounding and reverse polarity)

***** - basement- kitchen- no ground and reverse polarity circuits p13 (no permit taken)

Recommendation: hire an electrician to check all circuits and make repairs

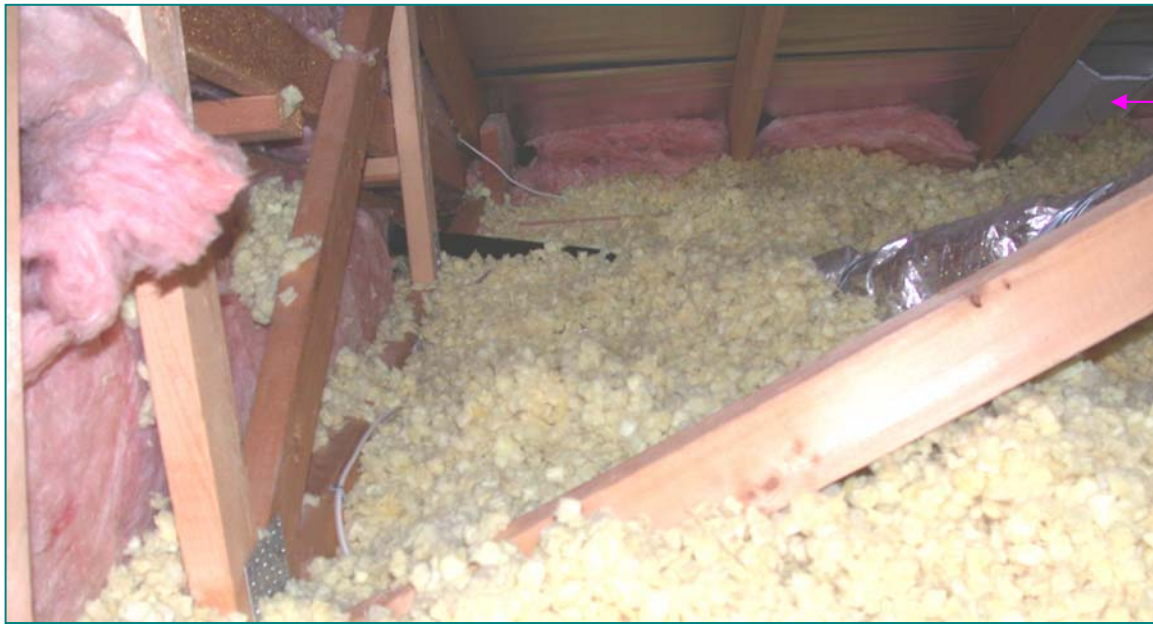
- approx R12 or less blown fiberglass insulation for all flat ceilings p15 (insulation is scattered and compressed reducing insulation values)

- insulation is contaminated with rodents droppings p15 (approx \$3.75- \$4/sq.ft)

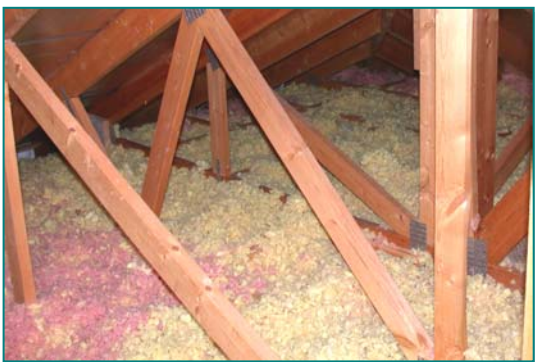
Soffit-stiro-vents
- ensuite bath fan exhaust duct is insulated-good

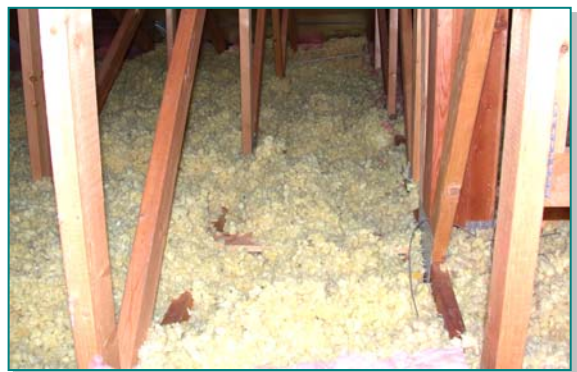
Note:
- thickness of insulation
- uneven distribution/cov erage

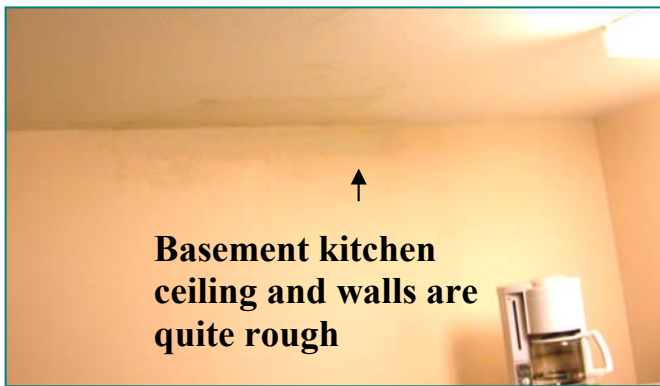
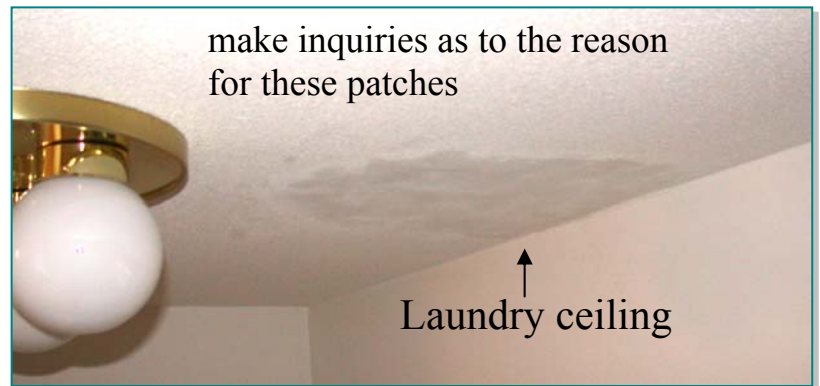
- **** - several ceilings repairs (rough) p16

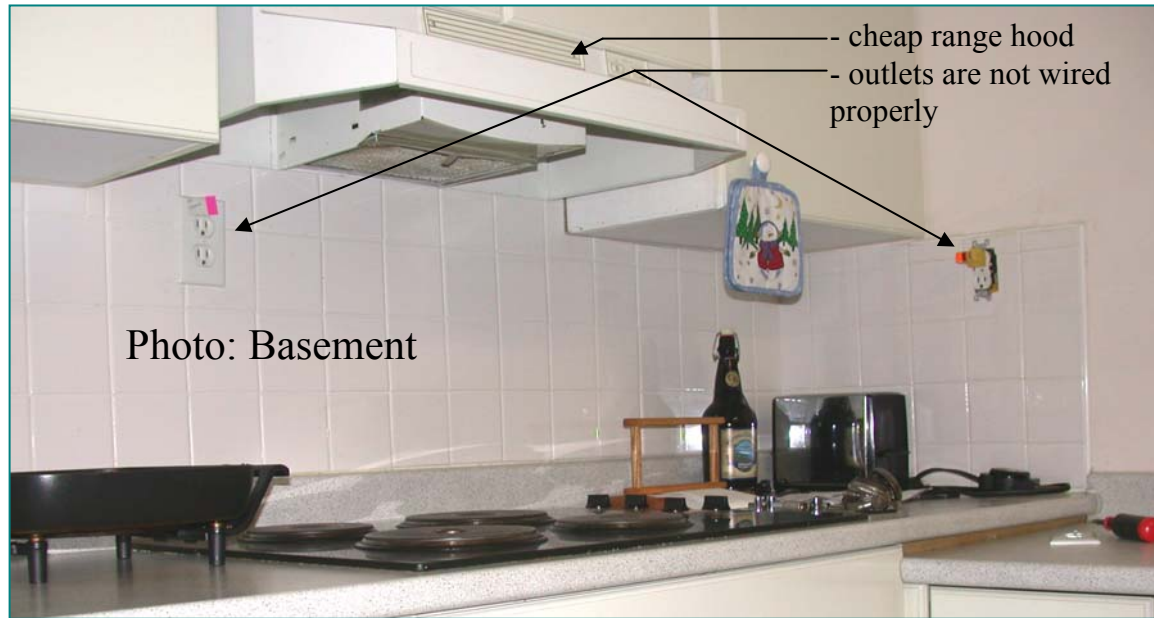
- basement stove top functioning At Time of Inspection (ATOI)
- main floor- stove and oven functioning (ATOI)
- **** - hood vents- functioning (ATOI)- low-volume- a bit noisy p17
