T.H.E. Home Inspection Company

For: John Smith

Address: Vancouver

Date: 2002

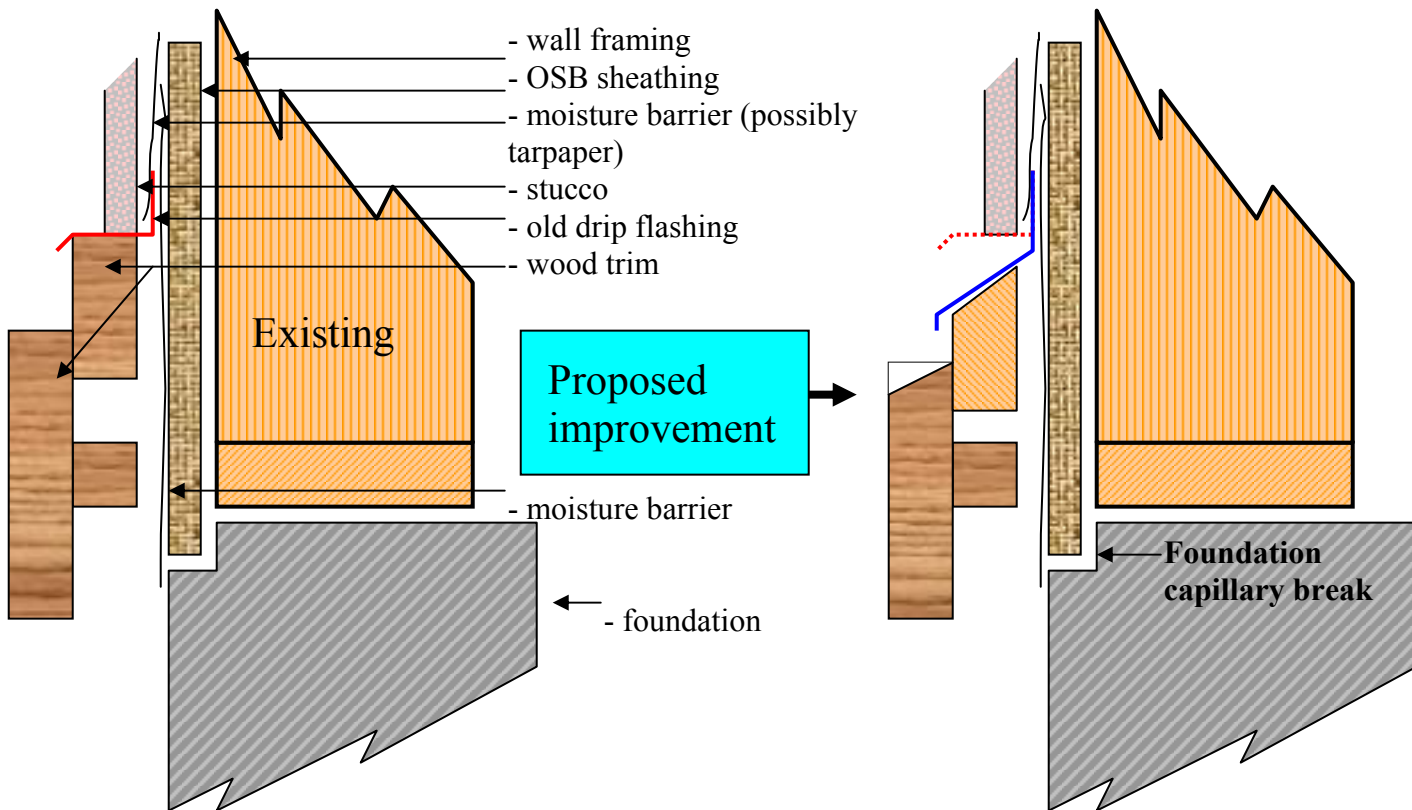
Wall and detail continued

**** - stucco terminates at/in foundation "capillary break"- possible capillary water ingress p8
